Samsung EVO 840 - 250 GB SSD

Repair Manual

Current version: 2.12.2024

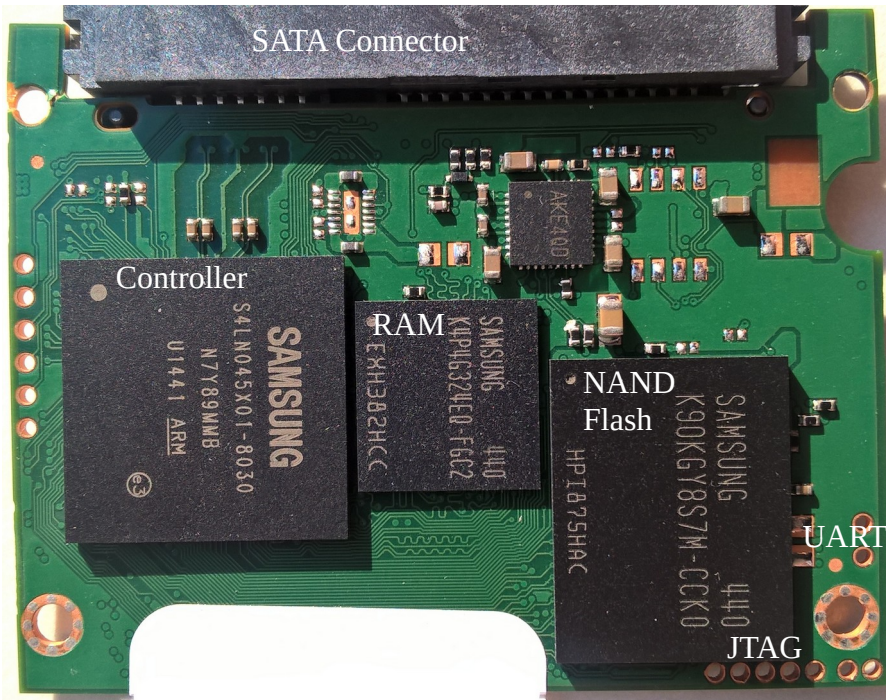
*Image 1:
Pentalobe*

So what do we have here?
The long thing on the upper end is the SATA connector, the big square chip on the bottom left is the controller CPU, in the middle we have some SDRAM and on the right side is the actual NAND Flash storage chip.

On the back side is the second NAND Flash chip in the same location (I guess that makes it easy to route the traces, perhaps the address lanes are shared)

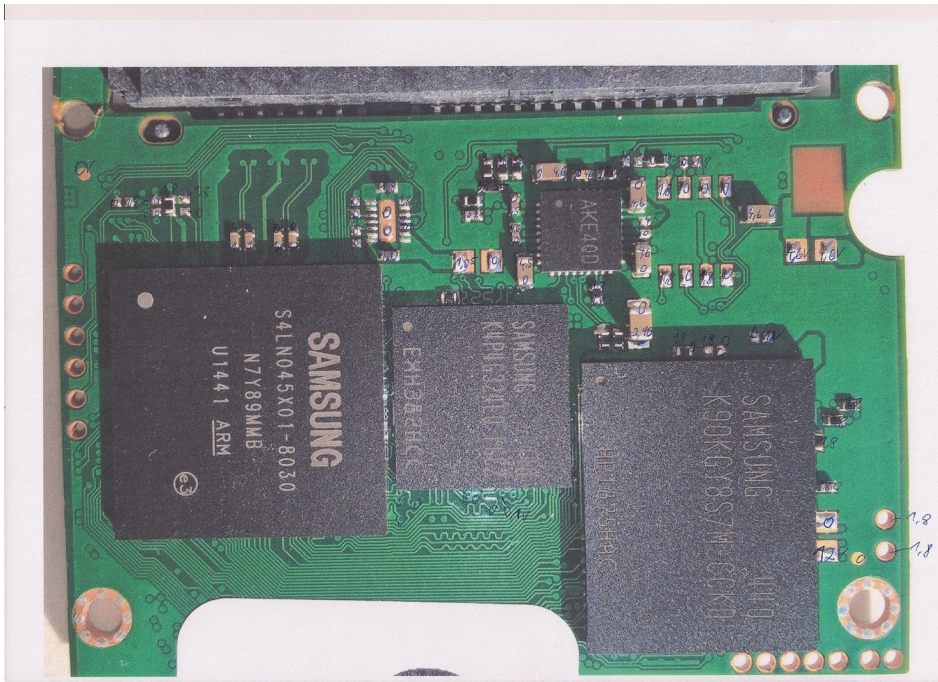
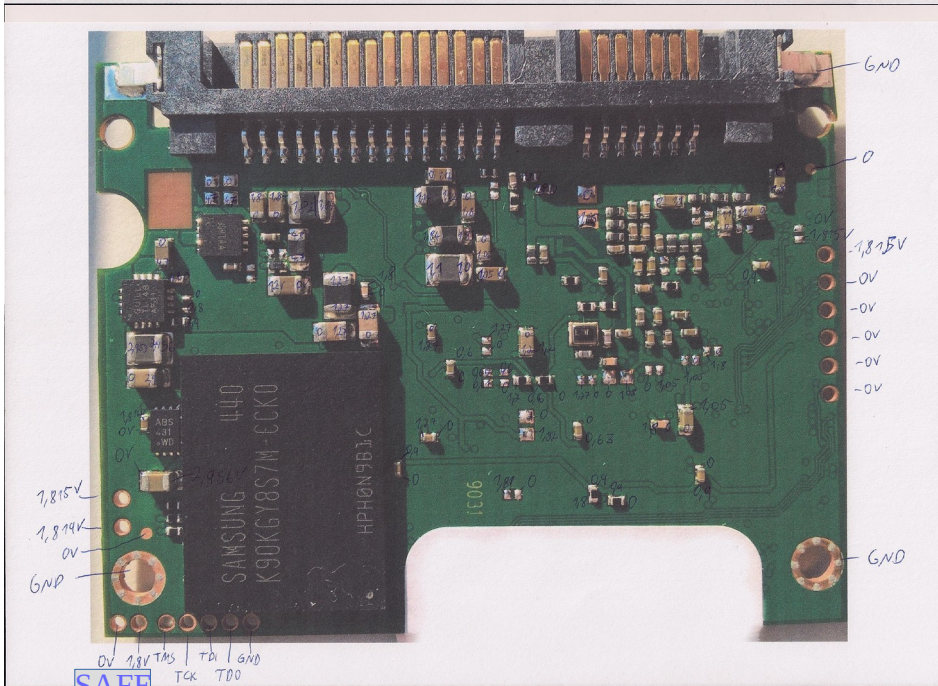
I powered the SSD and measured all the voltages on all the Pins I could find, first on a good SSD, documented on printed up-scaled photos and then verified them on my broken SSD, and the voltages were all OK.

The voltages on the SATA Data pins were identical too, so I have some more confidence that the problem is not a physical problem of the SATA interface, and that all the power-management is good.

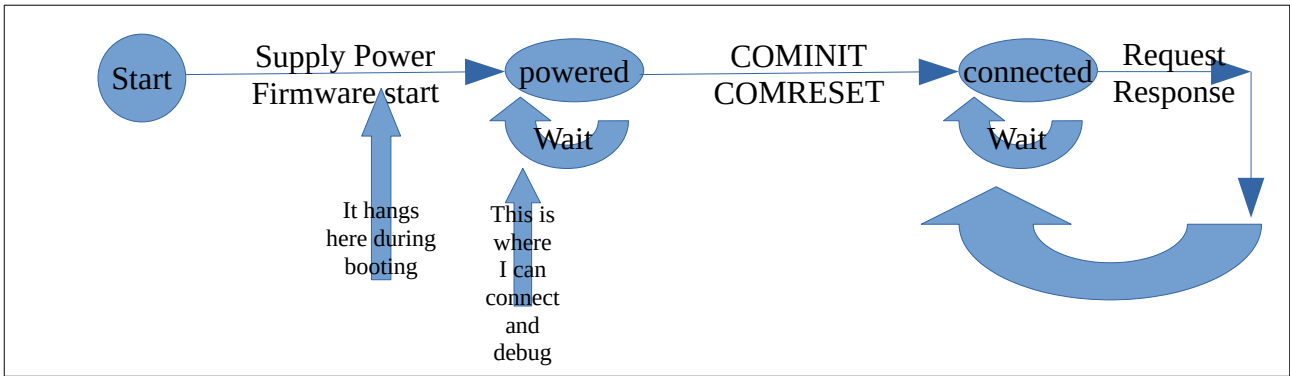
As soon as the SSD is connected with power, it starts the firmware, when the initialization is done, it starts waiting for a connection with the HOST computer (a small loop that checks the status register 0x200000AC bits for the COMINIT signal), when that signal is given, it continues by configuring the SATA PHY for the connection, and then it starts waiting for Requests from the computer.

The problem with my SSD is that the Firmware start seems to initialize the SATA PHY properly in the beginning, but it then somehow deviates from the correct program flow and does not get to the “powered wait” loop. If the firmware would get to the “powered wait” loop, it could get the COMINIT signal from the SATA PHY and could continue properly.

Later on, I found out that the reason is a problem in the flash channels that is detected by the firmware, and therefore it stops starting and does not enable the SATA interface.
