Samsung EVO 840 - 250 GB SSD

Repair Manual

Current version: 2.12.2024

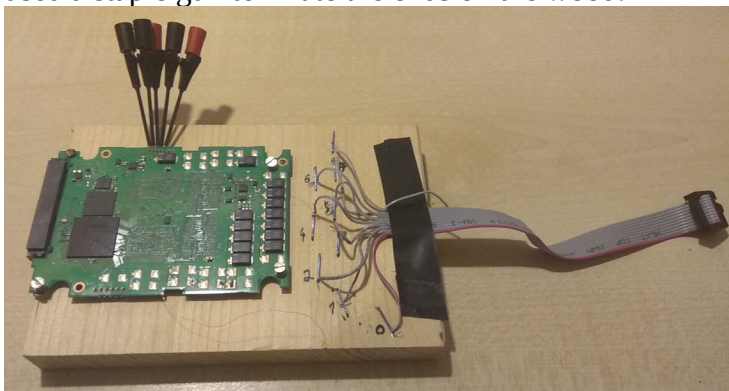
Since the board of the SSD bent slightly on pressure, I built a wooden fixture and screwed the SSD with spacers on the board. Then I got some Micro-Probes that I could use to interface with the JTAG pins. Then I took a 10-Pin cable, removed the connector and spliced it up on one end, and used a staple gun to fixate the ends on the wood.

With a crayon I documented which of the 8 logic analyzer channels is where.

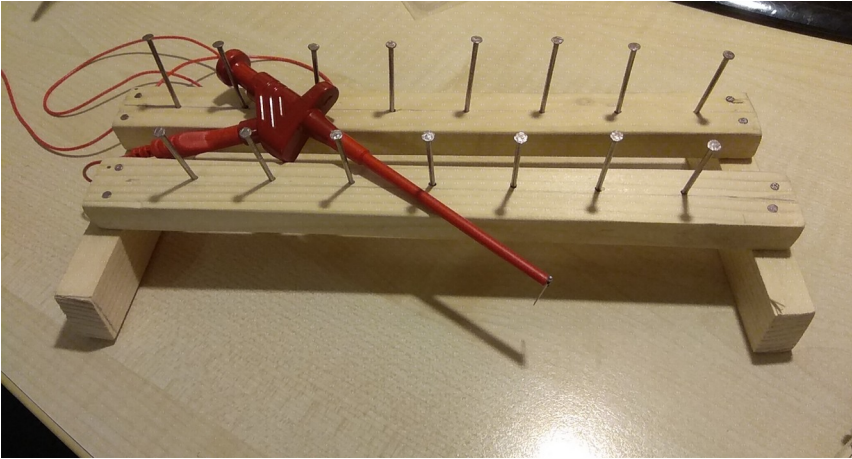
Then I found an old wooden game of my children. I took flexible test clip pinch grippers and attached needles in the front, and layed those on the game, so they became my flying probes.

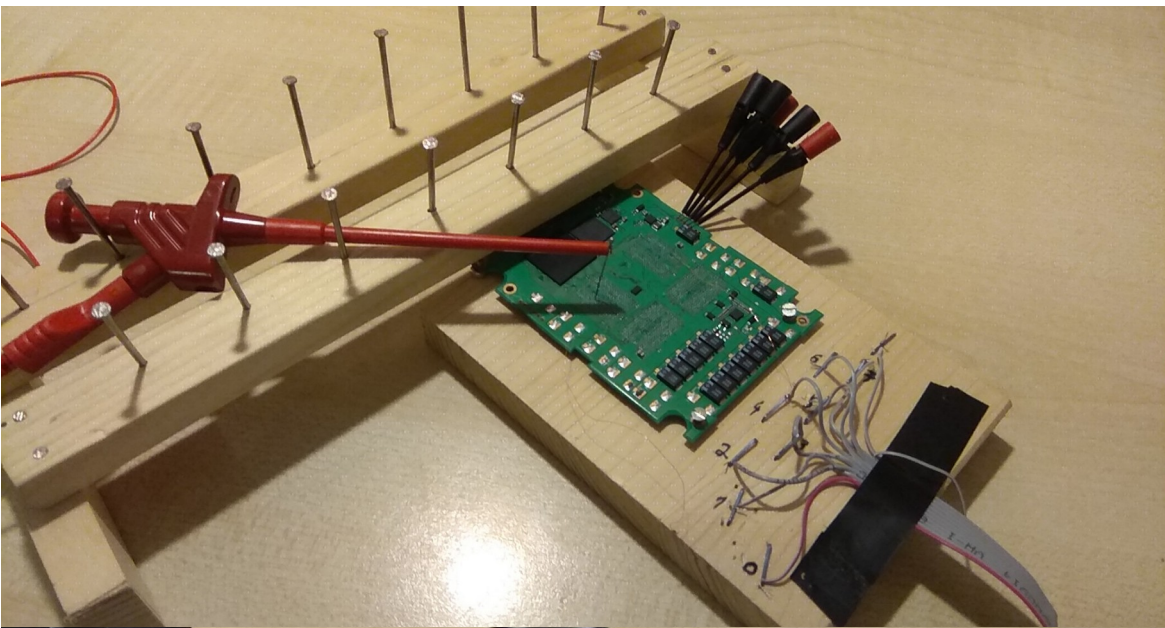
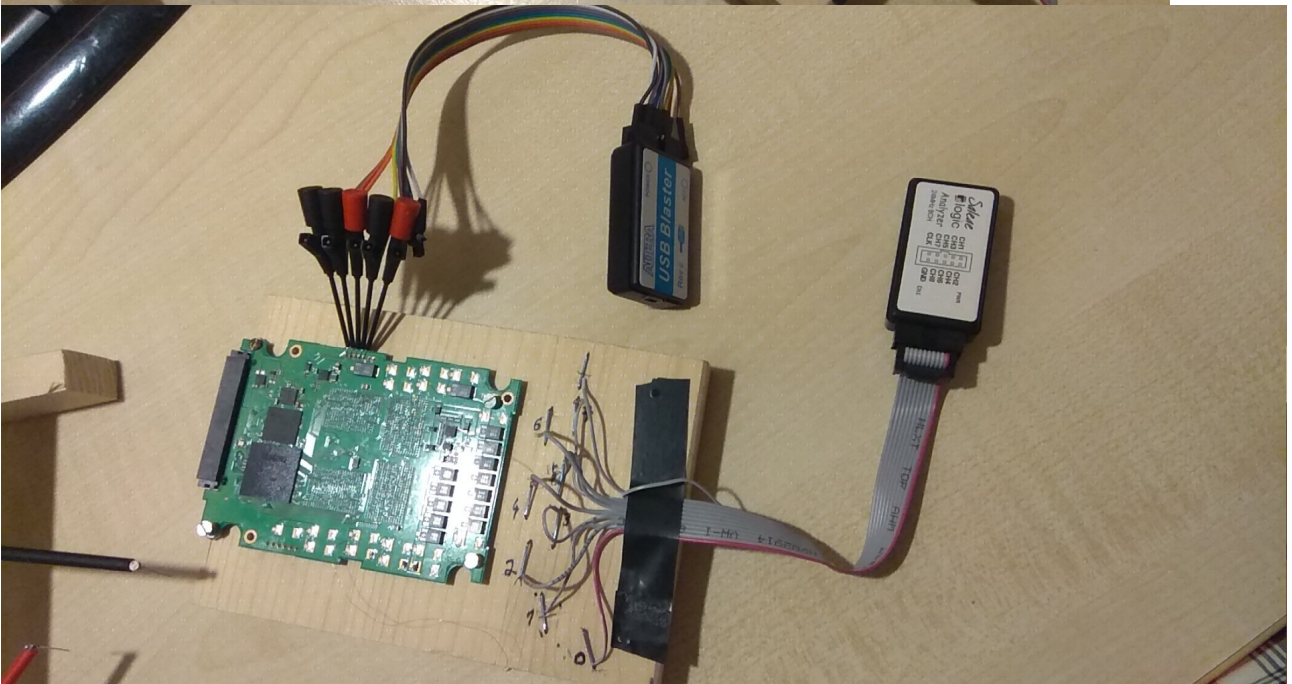
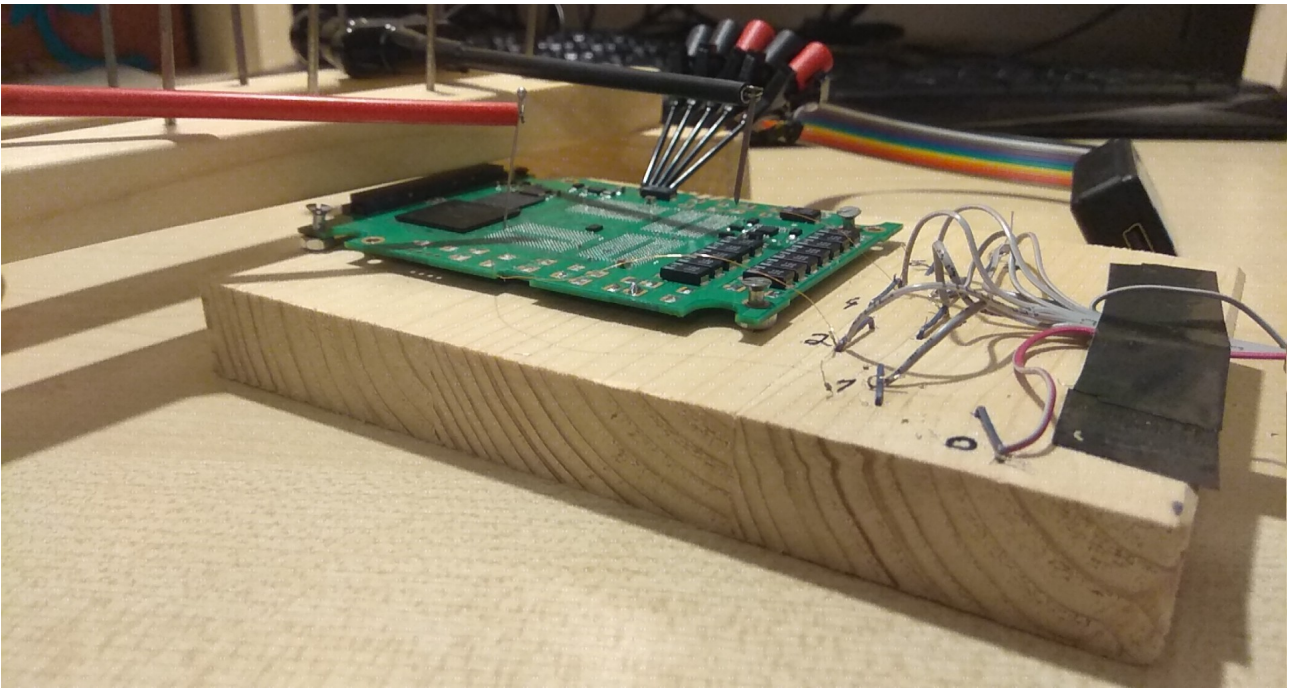
Then I combined both the fixture and the flying probes, and I was able to solder several copper wires permanently and also to directly measure individual BGA balls on demand.
